Enhanced Preliminary Assessment Report:

Fairfield Army Housing Units
Fairfield, Connecticut

October 1989

Environmental Research Division
Argonne National Laboratory
Argonne, Illinois 60439

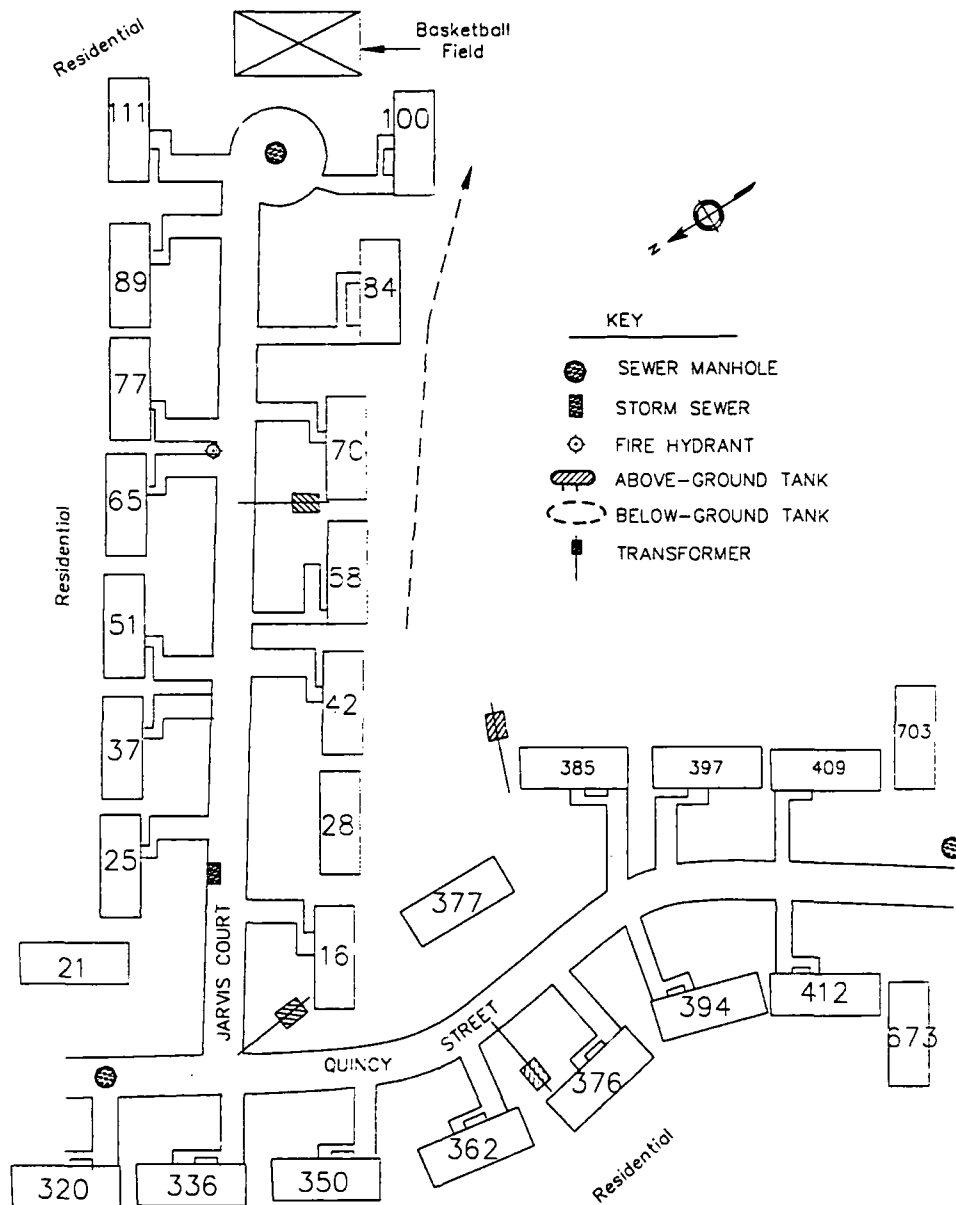
FIGURE 3 Site Plan Map of Fairfield Army Housing Units

Figure 3 presents the site plan of the housing property.

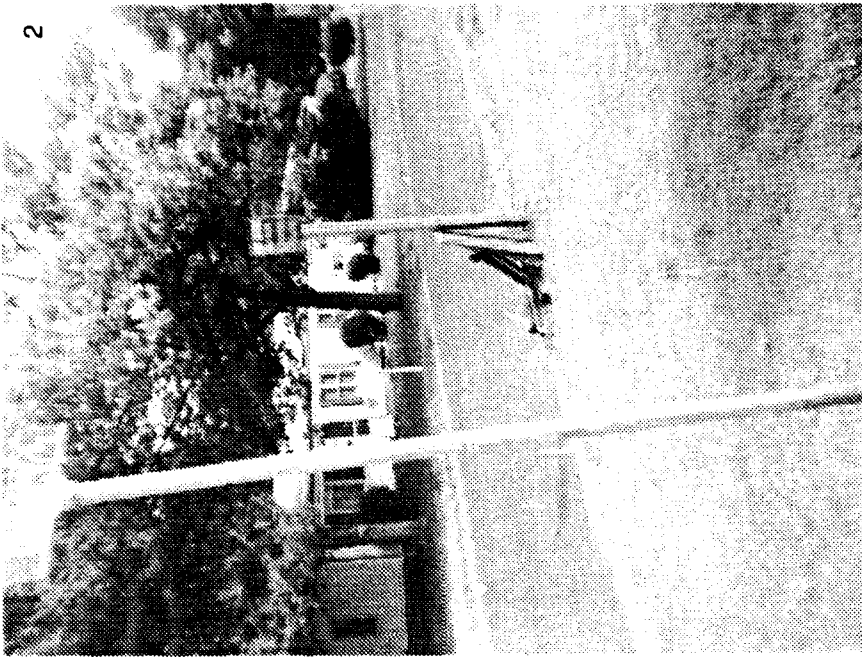
1. Entrance to the housing facility.
2. Capehart-style home.
3. Electrical transformer mounted near the top of a utility pole; transformers are the responsibility of the Fairfield Power Company, with the utility pole erected on government-easement land.
